Case study: Application of MBX® Bristle Blaster® Technology in maintenance works on Wind Power Stations

Project: Maintenance of Wind Power Stations, built in 2006

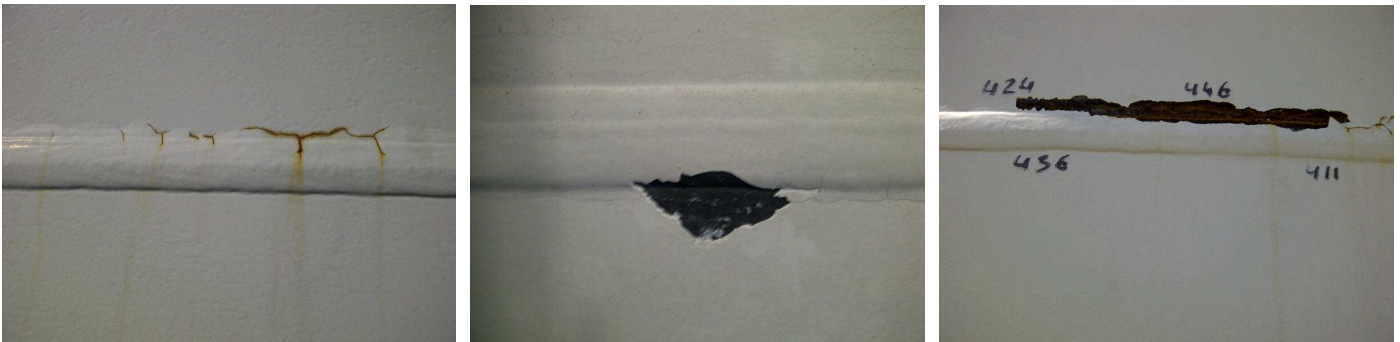
Welding seams connecting the segments show rust, partially paint has cracked from subjacent rust.

Examples of affected welding seams caused by rust

The welding seams must be treated by removing loose paint and rust, cleaning and simultaneously generating an anchor profile before applying the new coating.

Loose old painting shall be removed using a flap-wheel grinder, then cleaned and roughened by MBX® Bristle Blaster®. After this process a new layer of coatings has to be applied (priming and finishing coat).

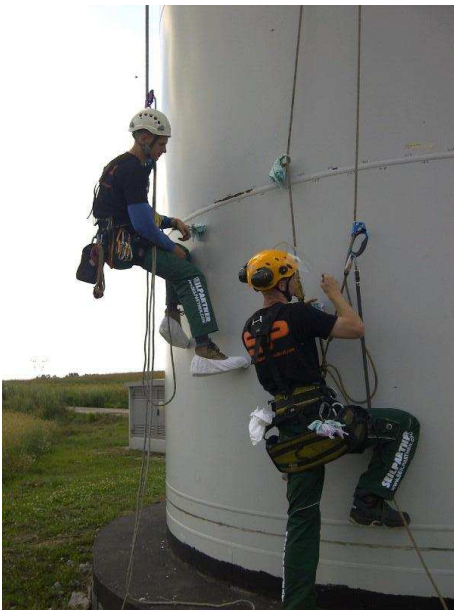
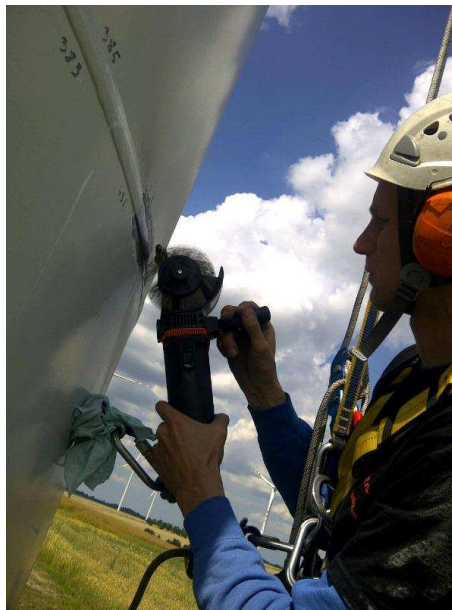
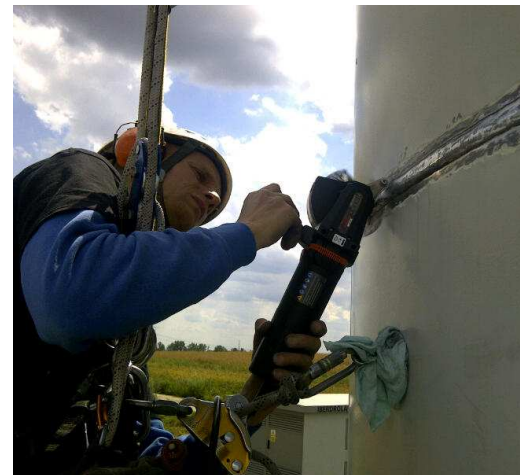
Application of MBX® Bristle Blaster® on wind power station

Per welding line approx. 2 to 2.5 hours are needed for surface preparation consuming on average 3 to 4 MBX® Bristle Blaster® belts.

As especially beneficial in this particular situation the application has been proven the MBX® QuickAd® which allowed changing the MBX® Bristle Blaster® belts fast and without additional tools.

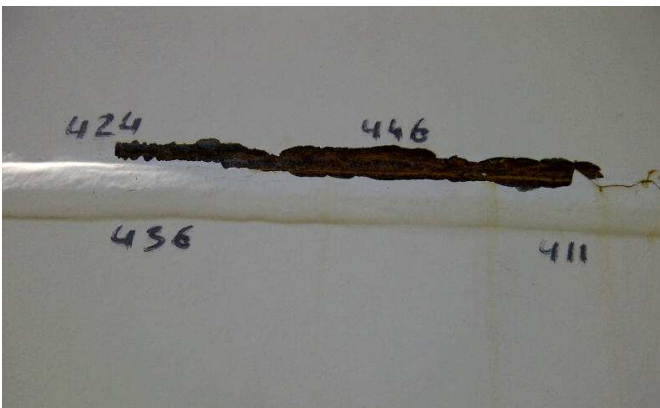
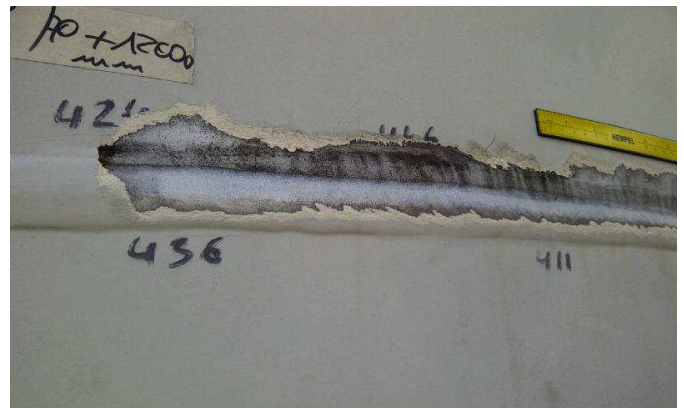
Welding seam before and after treatment with MBX® Bristle Blaster®

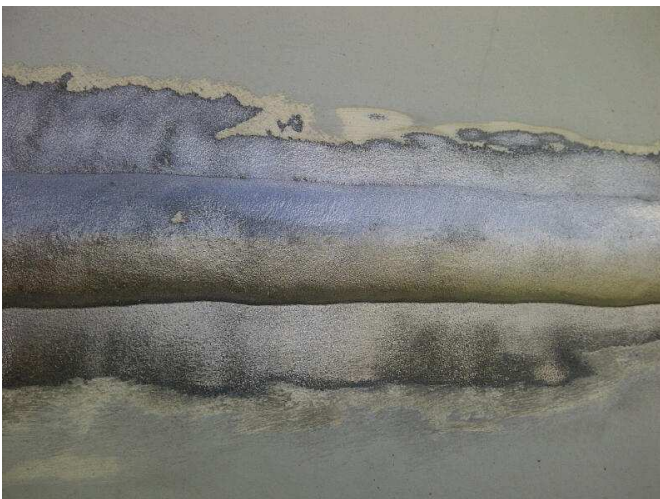
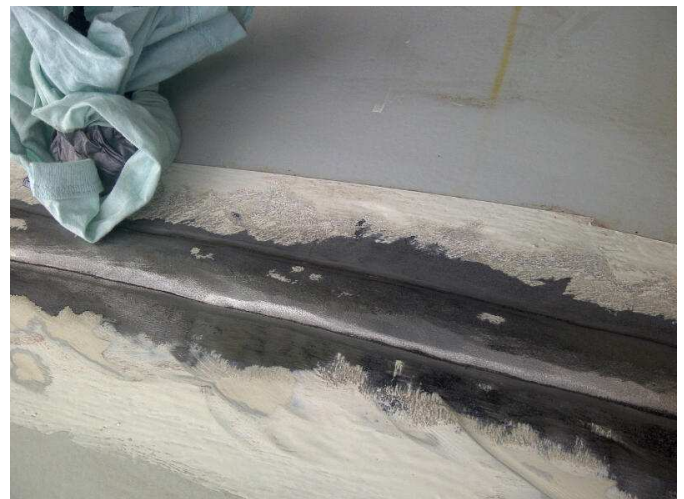
The generated anchor profile was measured with $76 \mu\text{m}$ (Rz). Although working in a hanging position makes it more difficult working with certain pressure against the surface, the measured roughness after 0.5 hours of using one belt was still $40 \mu\text{m}$ (Rz) and still sufficient as anchor profile.

Detailed view of cleaned and roughened welding seam
